## Current Schedule of Condition/Dilapidation Report

**Site Address:** 5/20 Sample Road,  
Sydney NSW

**Date:** 01 January 2012  
**WB Job Number:** 1234

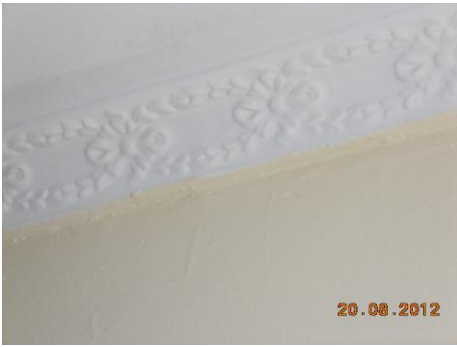
17.

Item Ref	Location	Element	Description	Condition	Photo Ref
	Flat 5 / 20 Sample Road, Sydney				
<b>1.0</b>	<b>Internals</b>				
<b>1.1</b>	<b>Kitchen</b>	<b>General</b>	Plastered and painted ceiling with perimeter coving, plastered and painted wall with timber skirting and tiling above worktop area and cork tiles to floor.	<ul style="list-style-type: none"> <li>• Minor hairline crack to ceiling adjacent to battens.</li> <li>• Hairline crack to perimeter of coving and junction of wall above window and bedroom elevations.</li> <li>• Damage to paintwork above wall units.</li> <li>• Hairline cracking to skirting at junction of wall to lounge elevation wall.</li> <li>• Uneven wall above door opening and window overlooking the lounge.</li> </ul>	<b>1-13</b>
<b>1.2</b>	<b>Lounge</b>	<b>General</b>	Plastered and painted ceiling with ornate perimeter coving, plastered and painted walls with timber skirting with carpet to floor.	<ul style="list-style-type: none"> <li>• Hairline cracking to perimeter of coving and junction of wall.</li> <li>• Hairline crack to wall above television where plasterboard infill.</li> </ul>	<b>14-22</b>

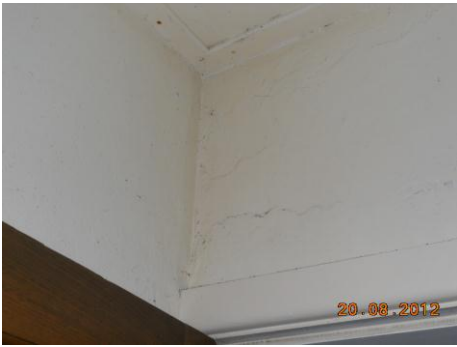
23.

<b>1.3</b>	<b>Bathroom</b>	<b>General</b>	Timber boarded bathroom ceiling with perimeter batten, plastered and painted	<ul style="list-style-type: none"> <li>• Flaking paintwork to walls at high level above window</li> </ul>	<b>23-32</b>

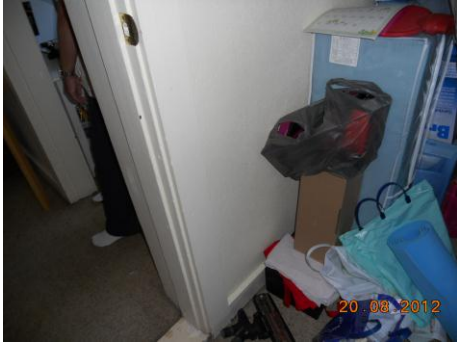
41.

Item Ref	Location	Element	Description	Condition	Photo Ref
			walls and part tiled and tiling to floor throughout.	<ul style="list-style-type: none"> <li>• Uneven plasterwork above and behind door.</li> <li>• Tiling in satisfactory condition with hairline crack to junction of tiles and door frame on hinge side.</li> </ul>	
<b>1.4</b>	<b>Bedroom</b>	<b>General</b>	Plastered and painted ceiling with perimeter coving, plastered and painted walls with timber skirting and carpets to floor.	<ul style="list-style-type: none"> <li>• Hairline crack to junction of coving and wall above door and vertical crack to corner above door.</li> <li>• Hairline crack at junction of skirting and architrave right hand side of door.</li> <li>• Hairline crack at skirting level and door frame on hinge side.</li> </ul>	<b>33-41</b>
