Schedule of Condition/Dilapidation

Site Address: Cinemas,
15 Sample Road,
Sample,
QLD 4123

- 1.1 This Schedule is intended to record the condition of the property known as Cinema, 15 Sample Road, Sample, QLD 4123 prior to commencing the refurbishment works to the entire cinema complex.

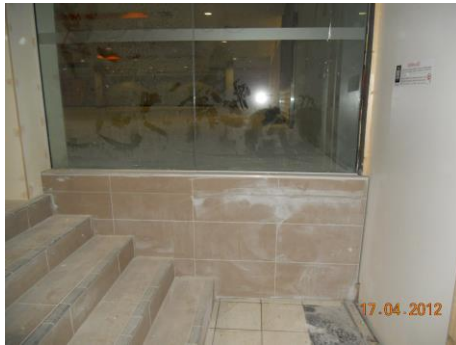
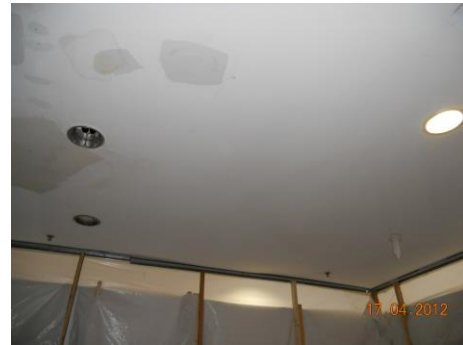
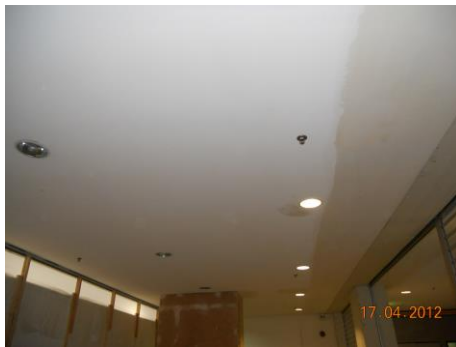
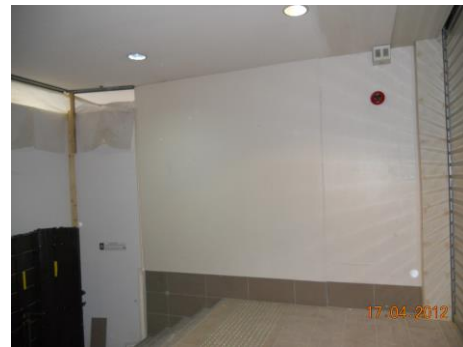
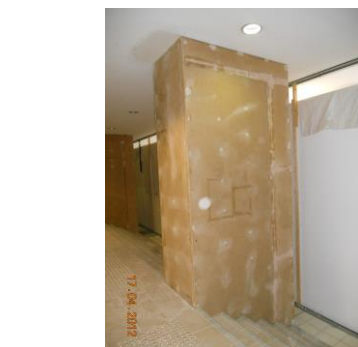
1.2	Entrance (behind hoarding)	Ceiling	Plastered and painted with recessed lighting and surface mounted sprinklers.	<ul style="list-style-type: none">• Evidence of water staining around lights near the entrance from the hoarding.• General decorations have been patch	7-36

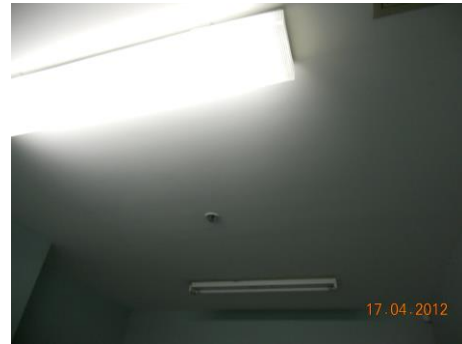
88.

1.6	Office 1	Ceiling	Plastered and painted with surface mounted fluorescent lighting and sprinkler head.	<ul style="list-style-type: none"> Generally satisfactory with 1 x diffuser missing. Grilles dirty. 	88-99

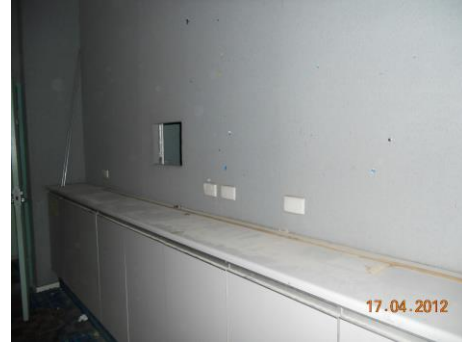
135.

1.9	Ticketing Counter	Ceiling	Plastered and painted with recessed spotlight and air-conditioning vents and 3 x fans.	<ul style="list-style-type: none"> • In poor decorative order with an access hole cut through and left unfinished. 	134-143
		Walls	Fabric lined walls with fitted cupboard.	<ul style="list-style-type: none"> • In poor condition. • Generally dirty. 	
		Floor	Carpets.	<ul style="list-style-type: none"> • Poor condition with staining. • Generally dirty throughout. 	
		Door	Painted timber door.	<ul style="list-style-type: none"> • In poor decorative order. 	
		Counter Area	Fitted melamine counters for serving.	<ul style="list-style-type: none"> • In poor condition.
